Elevated Temperature Aqueous Stress-Corrosion  
of Stainless Steel5. TYPE OF REPORT & PERIOD COVERED  
Final Technical Report  
Apr 80 - Dec 80

M.G. Lackey, H.M. Flower and F.J. Humphreys

Imperial College of Science and Technology,  
Prince Consort Road  
London (England)10. PROGRAM ELEMENT, PROJECT, TASK  
AREA & WORK UNIT NUMBERS6.11.02A  
1T161102BH57-04

6 ELEVATED TEMPERATURE AQUEOUS STRESS-CORROSION OF STAINLESS STEEL.

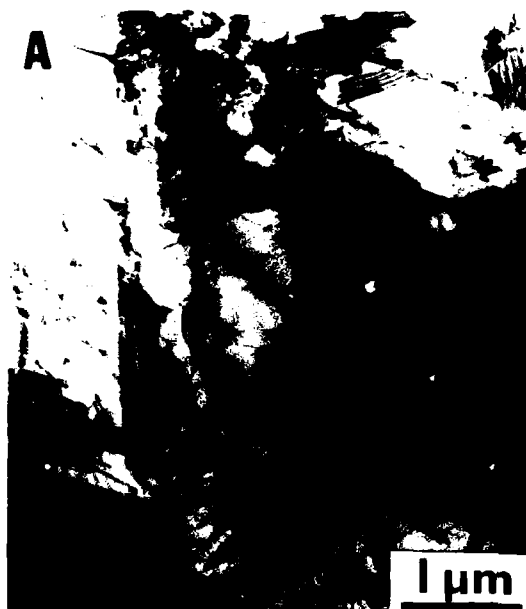
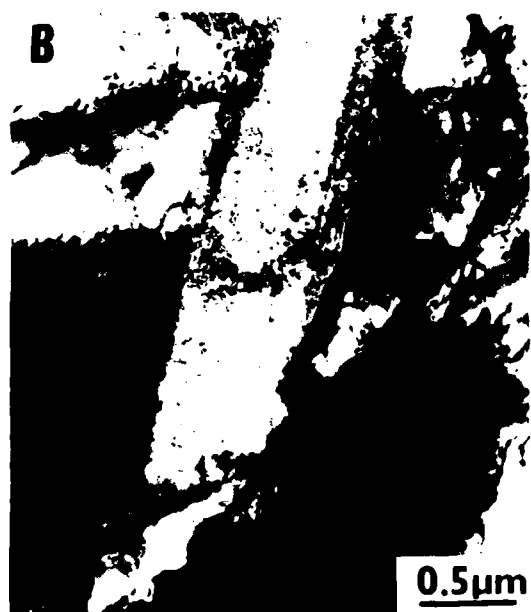
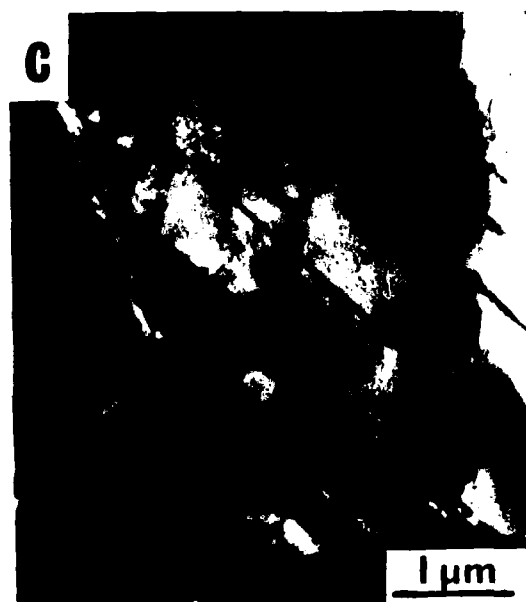
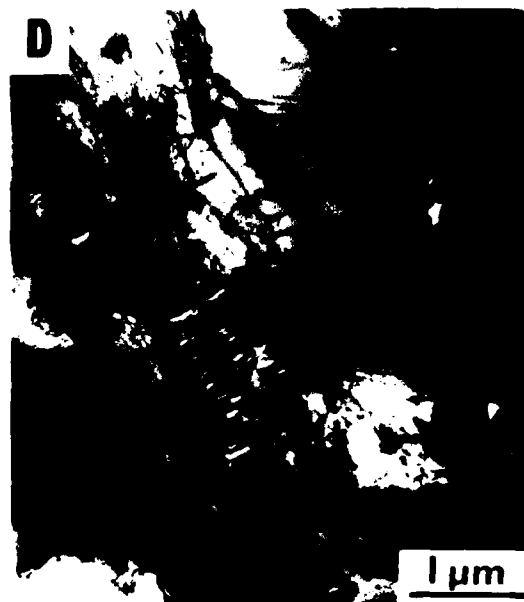
Figure 5. Representative Micrographs of Heavily  
Sensitised Specimens (72 hrs. @ 675°C)  
After Cathodic Charging at 25°C .

The microstructural effect of hydrogen in sensitised austenitic stainless steel was evaluated through examination of cathodically charged specimens. Electrolytic charging was conducted in a 2 vol %  $H_2SO_4$  solution, containing 250 mg/l of sodium arsenate as a hydrogen recombination poison. Thin foil specimens were charged for periods of 3 to 15 min. at a current density of approximately  $70 \text{ mA/cm}^2$  at  $25^\circ\text{C}$ . Examination of the charged specimens in the transmission electron microscope revealed extensive faulting and twinning of the austenite (Fig. 5A). This rather high degree of deformation induced the transformation of  $\gamma \rightarrow \alpha'$  at many grain boundaries (Micrograph B). Regions of  $\epsilon$  martensite were observed in the  $\gamma$  after charging (Micrographs A and C). In addition to the deformation structures, intragranular cracking was detected (Micrograph D). The cracks were crystallographic in nature and appear to grow in  $\langle 111 \rangle$  directions. The observed crack morphology and crystallography are remarkably similar to the slotted dissolution morphology observed by Scamans in studies

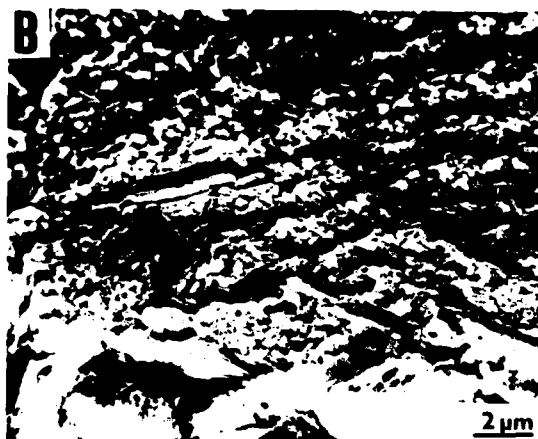
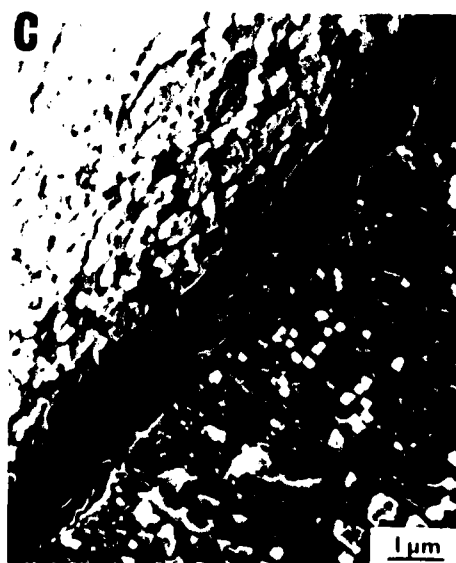
Figure 6.

Representative Fractographs of Sensitised  
Specimens (72 hrs. @ 675 °C) Tested  
in pH=2 0.01M H<sub>2</sub>SO<sub>4</sub> + 0.002M NaCl Solution  
Under Cathodic Control (-650 mV SCE)

The primary fracture mode in the 72 hour specimens was intergranular, with cleavage-like regions becoming more prominent as the sensitisation time decreased. Micrograph A in Figure 6 is typical of the 72 hour specimens. Indications of hydrogen cracking are evident in Micrograph B where fine transgranular cracks can be detected on a carbide-covered intergranular face. The absence of dissolution attack is demonstrated in Micrograph C which contains a high magnification micrograph of an intergranular crack. Depressions can be seen on the grain where once carbides had been present.

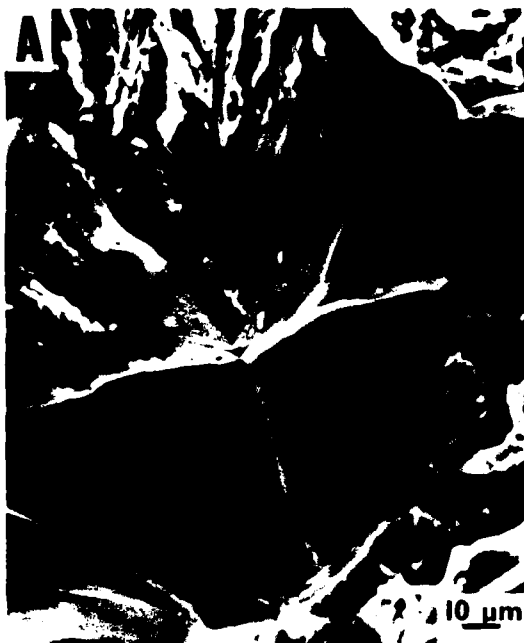
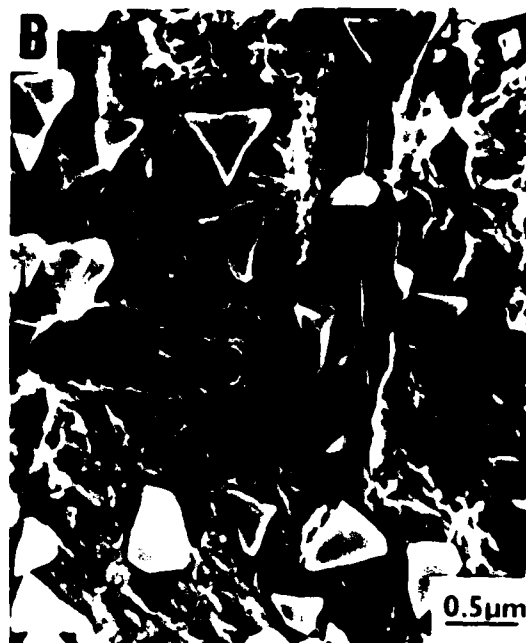
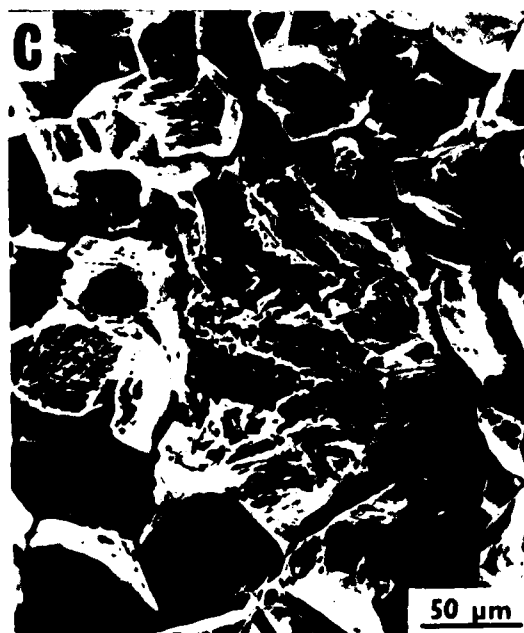
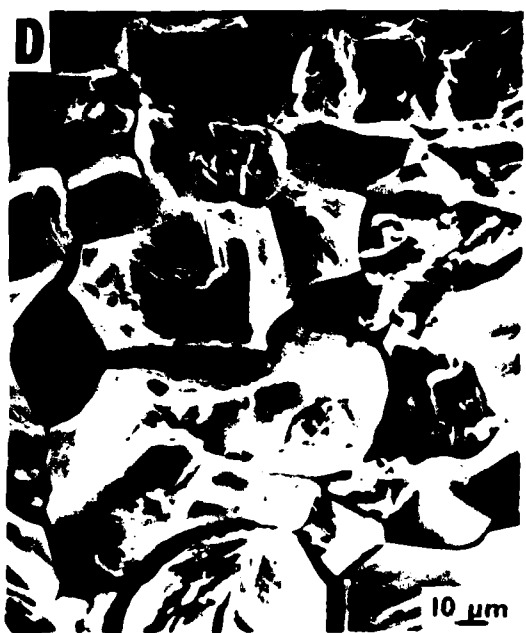
Representative Fractographs of Specimens  
Sensitised for 24 hrs. @ 675 °C Tested  
Under Cathodic Control in:

A,B,D) pH=2 0.01M  $\text{H}_2\text{SO}_4$  + 0.002M NaCl

C) pH=1 0.1M  $\text{H}_2\text{SO}_4$  + 0.02M NaCl

Specimens sensitised for 24 hours exhibited similar behaviour when tested under cathodic potential. Two fracture modes - intergranular and cleavage-like - characterised these failures. Strains to failure were slightly greater than those for the 72 hour specimens. Slip lines are visible in the intergranular region portrayed in Micrograph A in Figure 7. Individual carbides were still easily resolved (Micrograph B). Representative micrographs of fracture surfaces examined after testing in the pH=1 and pH=2 solutions, are presented in Micrographs C and D respectively. Some slip line attack can be observed in Micrograph C. No difference in strain to failure was detected for these specimens.

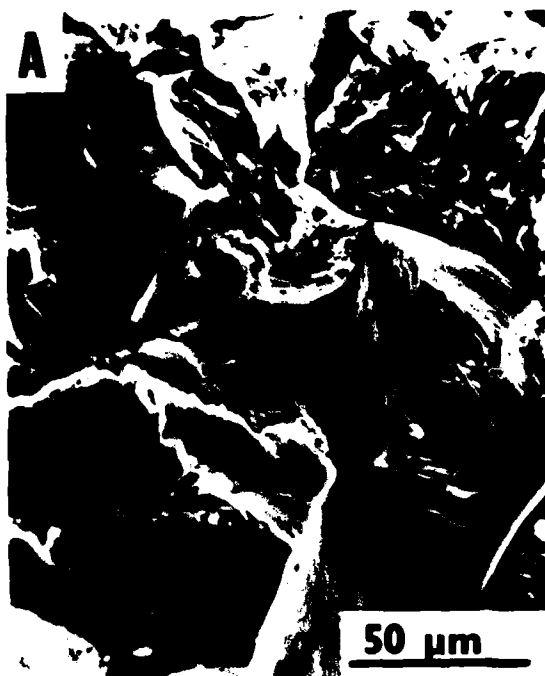
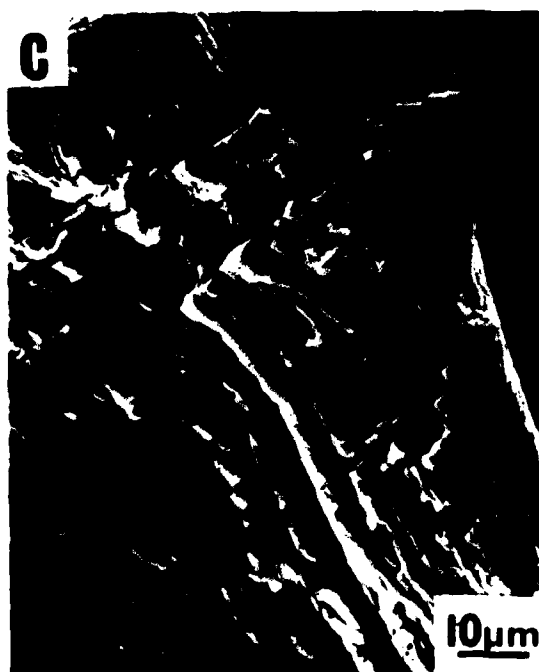
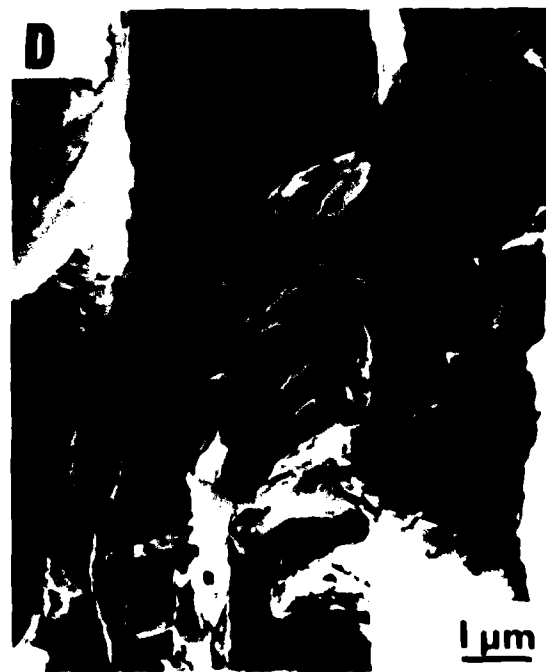
Figure 8.

Representative Fractographs of Specimens  
Sensitised for 2 hrs. @ 675 °C and Tested  
Under Cathodic Control (-650 mV SCE)

The greatest failure strains were associated with the specimens sensitised for 2 hours. Once again, the fracture surface was characterised by regions of intergranular and cleavage-like failure, as illustrated in Fig. 8 (Micrograph A). Secondary cracking on an intergranular face is shown in Micrograph B. The cracking is crystallographic, as would be expected for the case of hydrogen cracking. Micrographs C and D contain additional

examples of transgranular fracture. It appears to be crystallographic and fine in structure.

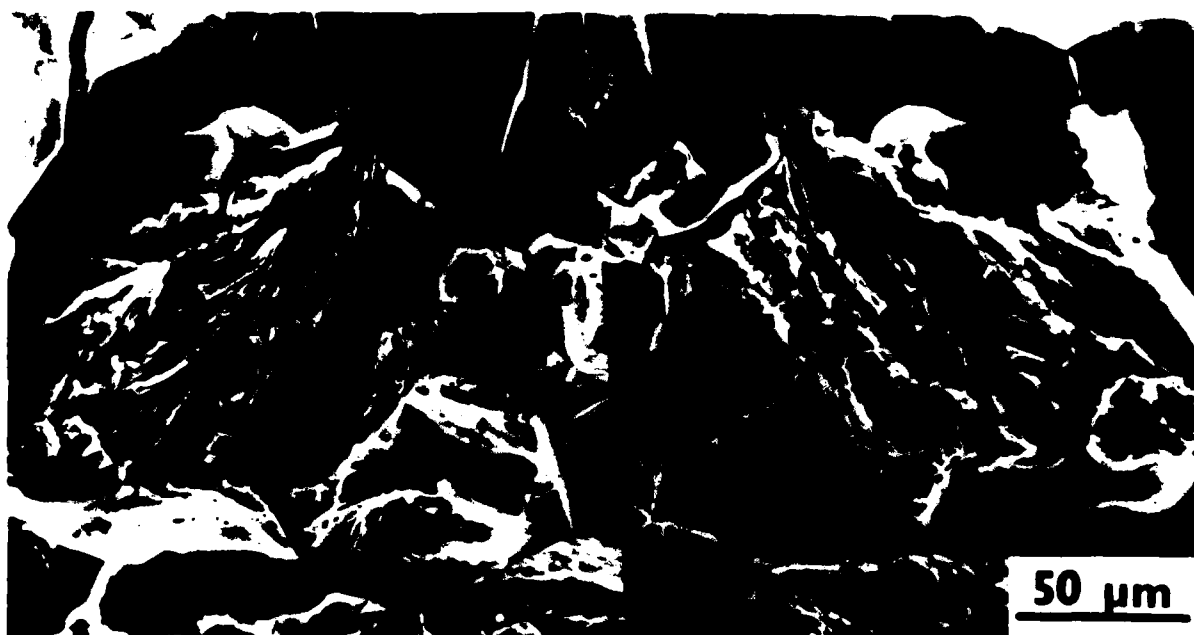
Figure 2.

Matching Fracture Surfaces From Sensitised Specimens (24 hrs. @ 675°C) Tested in pH=2 0.01M  $\text{H}_2\text{SO}_4$  + 0.002M NaCl Solution Under Cathodic Control (-650 mV SCE).

The lower right-hand micrograph is reverse printed to enable a comparison of the features to be made.

Fracture matching was undertaken in order to confirm that the cleavage-like fracture was not related to slip but rather due to embrittlement. Micrographs of matched fracture surfaces are presented in Figures 9 and 10. Also included in Figure 9 are two matching micrographs of the cleavage-like fracture; one micrograph is reverse-printed so that a detailed comparison of the features may be made. The second set of matched micrographs (Fig. 10) depicts the effect of the acid environment on the fine, cleavage-like structure. The left fracture surface was kept under cathodic control. The opposite face however was not cathodically protected after fracture and was permitted to corrode freely for approximately 3 hours. A small amount of attack occurred, and corrosion product can be readily detected in the right micrograph.

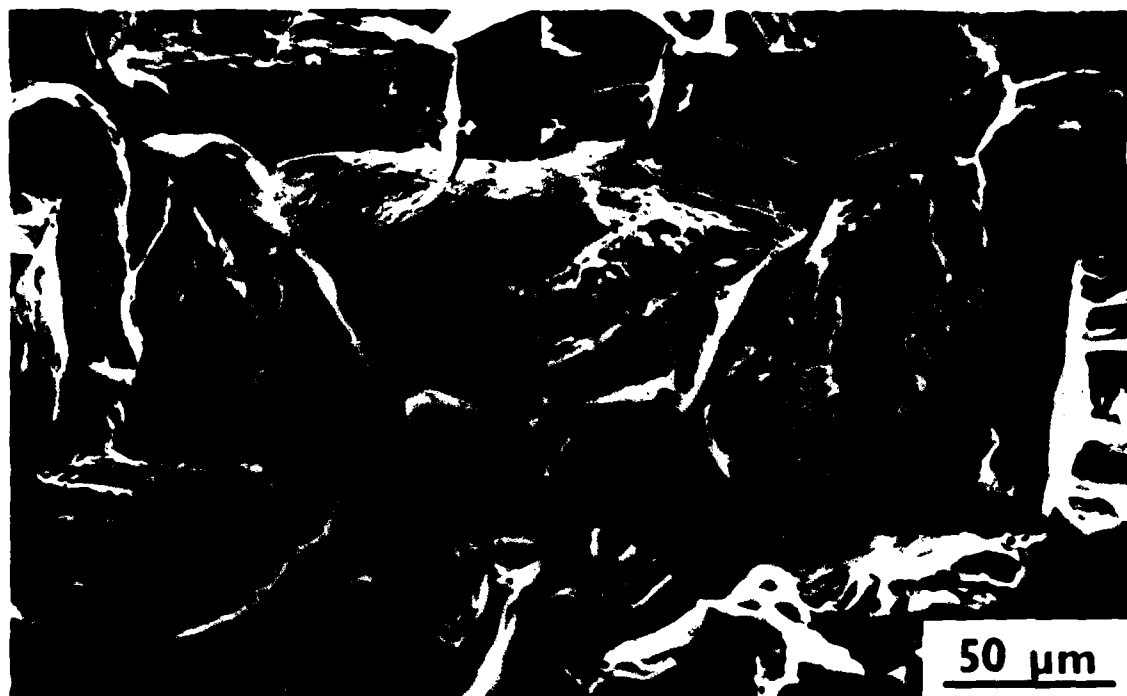
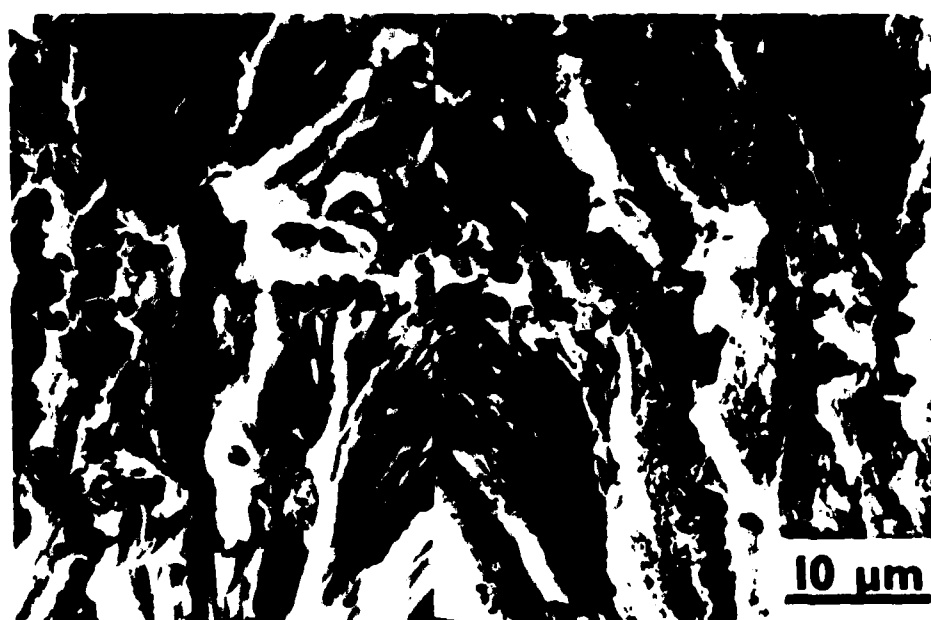
Figure 10.

Matching Fracture Surfaces From Sensitised Specimens (24 hrs. @ 675°C) Tested in pH=2 0.01M  $H_2SO_4$  + 0.002M NaCl Solution Under Cathodic Control (-650 mV SCE).

The effect of post-fracture dissolution can be observed in the lower micrographs. The surface on the left was exposed to the solution while under cathodic protection, while that on the right was permitted to corrode freely.
